DOT/FAA/AM-95/18

A Human Factors Evaluation of the Operational Demonstration Flight Inspection Aircraft

May 1995

Final Report

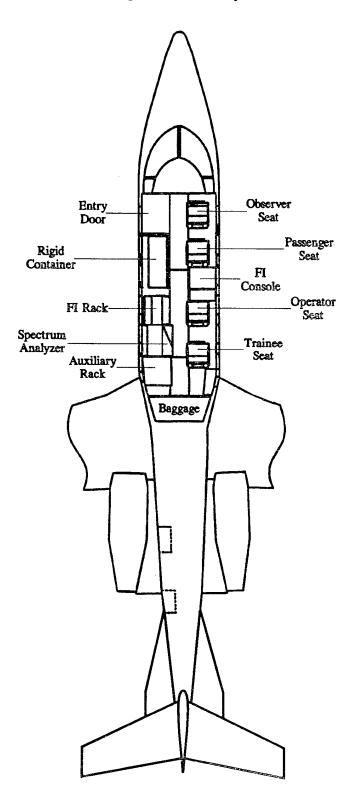
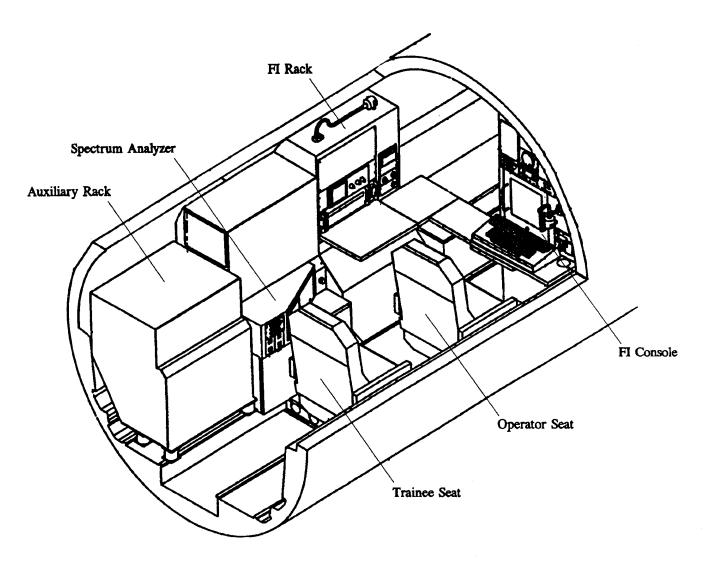
FIGURE 8
Proposed Cabin Layout

- The recorder was positioned in a manner that would make it difficult to write on its associated printout. It was positioned on the left of the aircraft, requiring right-handed technicians to reach across their bodies to annotate the printout when facing the plasma display.

- 2. The spectrum analyzer is positioned to the lower left of the forward-facing technician's seat. It is possible to position the display for this unit at a higher level on one of the two instrument panels for easier viewing. The control unit can be located remotely.

- 3. No provision for storage space for equipment and documents was indicated in the mock-up. The spectrum analyzer position, if fitted with a door, would provide adequate storage. This option depends on the spectrum analyzer display and control unit being moved, as suggested above in point 2.

- 8. Windows are not proposed for installation on the right side of the aircraft cabin at the technician's workstation. It would be beneficial to provide the technician with these windows.

The main difference between the two layouts is the side of the aircraft on which the workstation is positioned. The original design proposal called for the workstation to be positioned on the left side of the aircraft, requiring right-handed technicians to reach across their body to annotate the recorder printout. The contractor initially did not suggest a right-handed workstation, since the size requirements for the rigid container restricted its placement in the aircraft cabin. It was suggested to AVN that the rigid container should not drive the design and layout of the technician's workstation. The rigid container specification was modified to allow for the repositioning of the workstation to the right side of the cabin. The suggestion to move the workstation to the right side of the air-

- 9. The workstation should be positioned on the opposite side of the aircraft to avoid the problem described in point 1. This would require the specification of the rigid container to be changed. The rigid container should not drive the design and layout of the technician's workstation.

Based on the above considerations the contractor modified the design that had originally been proposed for integrating the flight inspection workstation into the aircraft. Each of the above points was addressed in the redesign of the revised workstation. Drawings of the original design and the design accepted by the agency are presented for comparison (Figures 8 through 11). Figures 8 and 9 detail the original aircraft cabin and technician's workstation layout, Figures 10 and 11 detail the design accepted by the agency for installation in the Lear 60 MSR FIA.

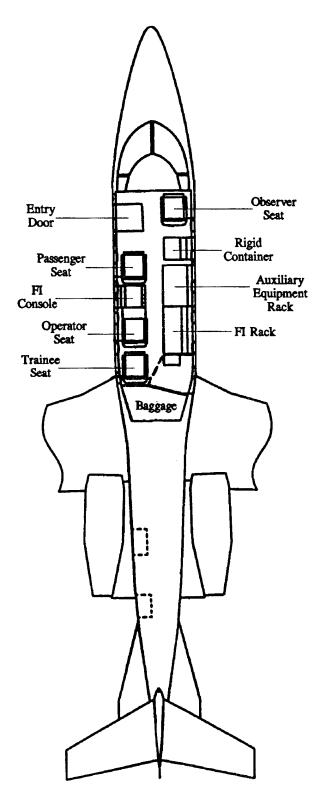
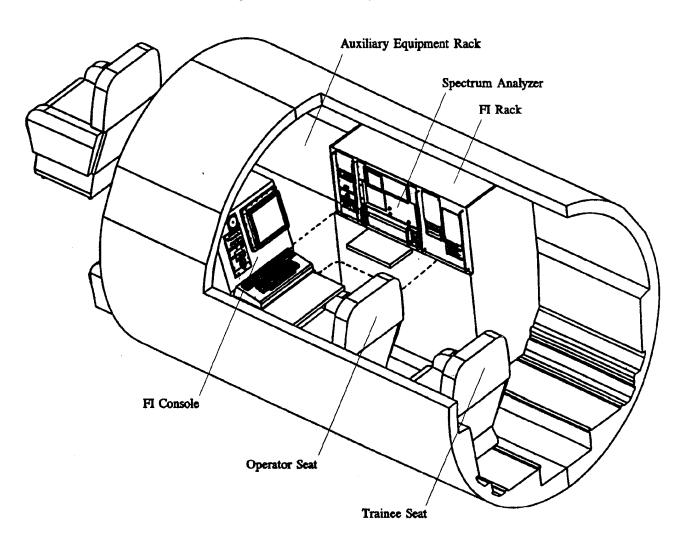
FIGURE 10
Accepted Cabin Layout

craft was incorporated into the design accepted by the agency It was contended that since the workstation had to be either right- or left-handed, it should accommodate the majority of the user population.
